Altadena Coalition of Neighborhood Associations (ACONA)

Let's keep Altadena
"The best neighborhood in LA
County"!
March 26, 2019

Southern California Edison Vegetation Management Overview ACONA

UTILITY PRUNING PRACTICES AND CONSEQUENCES

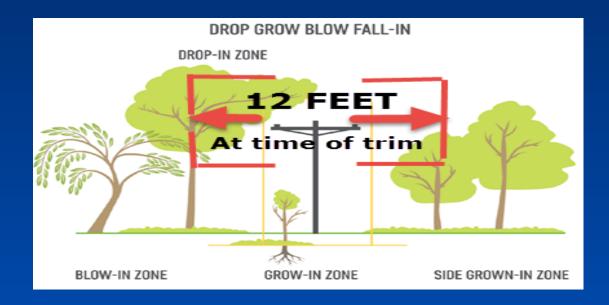
Clearance Illustration

SCE Vegetation clearance requirements align with industry best practices

Where overhead conductors traverse trees and vegetation, safety and reliability of service demand that certain vegetation management activities are to be performed to establish and maintain necessary and reasonable clearances

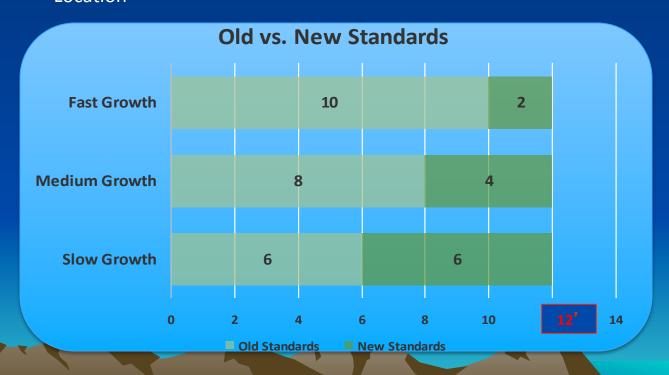
New Tree Pruning Standards

In 2017, GO 05, Rule 35 Appendix E adopted new recommended minimal clearances at time of trim. These clearance requirements in high fire areas are 12. Additional clearances may be required due to the factors below:

- Line dynamics
- Tree dynamics
- Tree characteristics
- Location

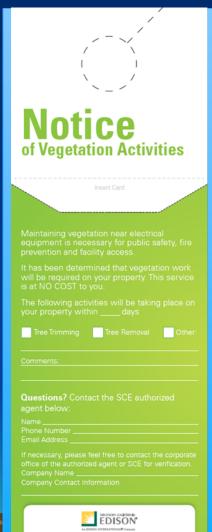
Customer Notification Pre-Inspection Door Hanger

SCE Consulting
Utility Foresters are
ready to answer any
customer concerns

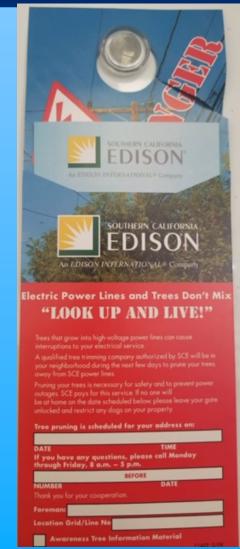
Customer Notification Tree Pruning Door Hanger

SCE Consulting Utility Foresters are ready to answer any customer concerns

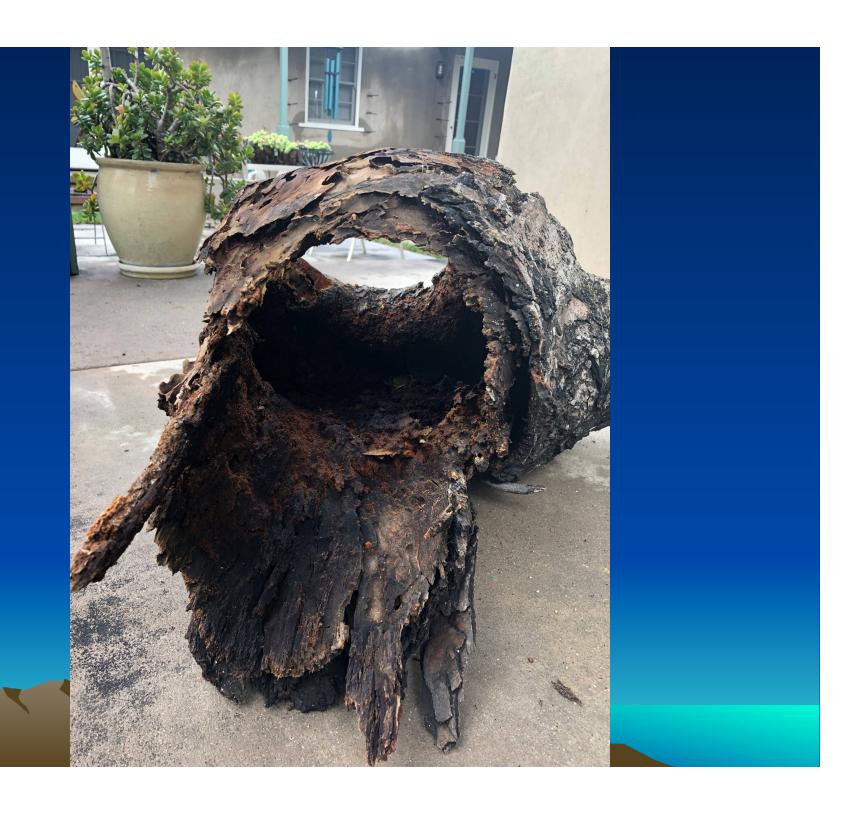
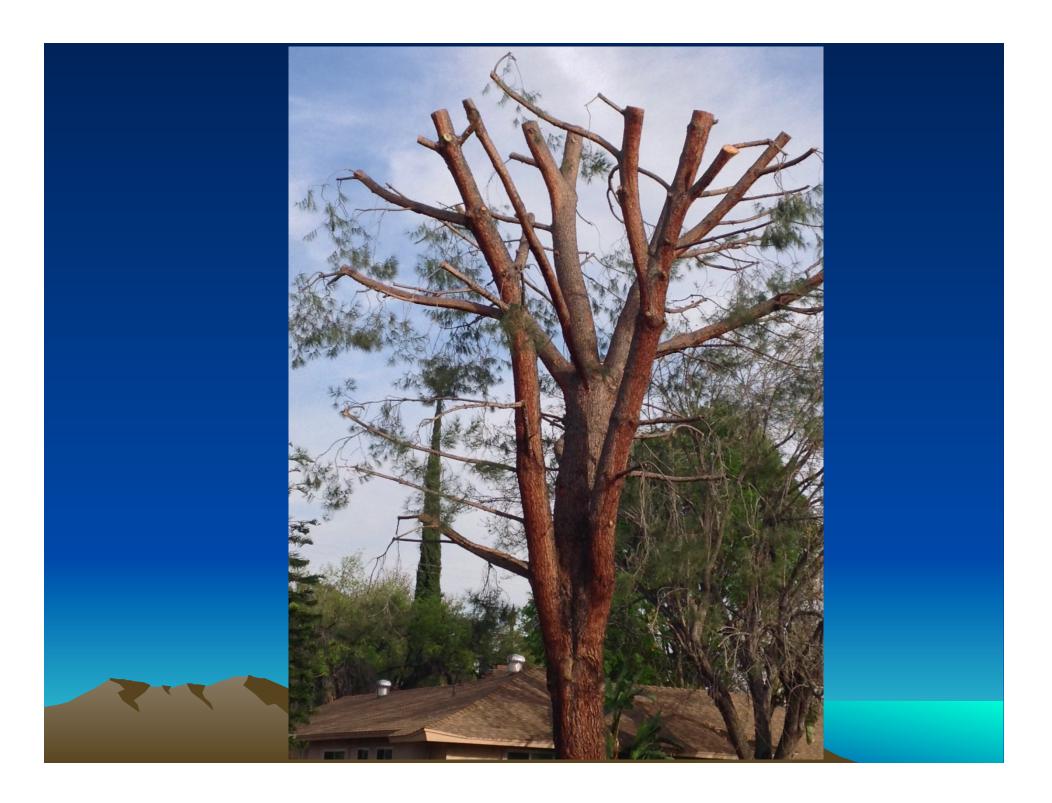
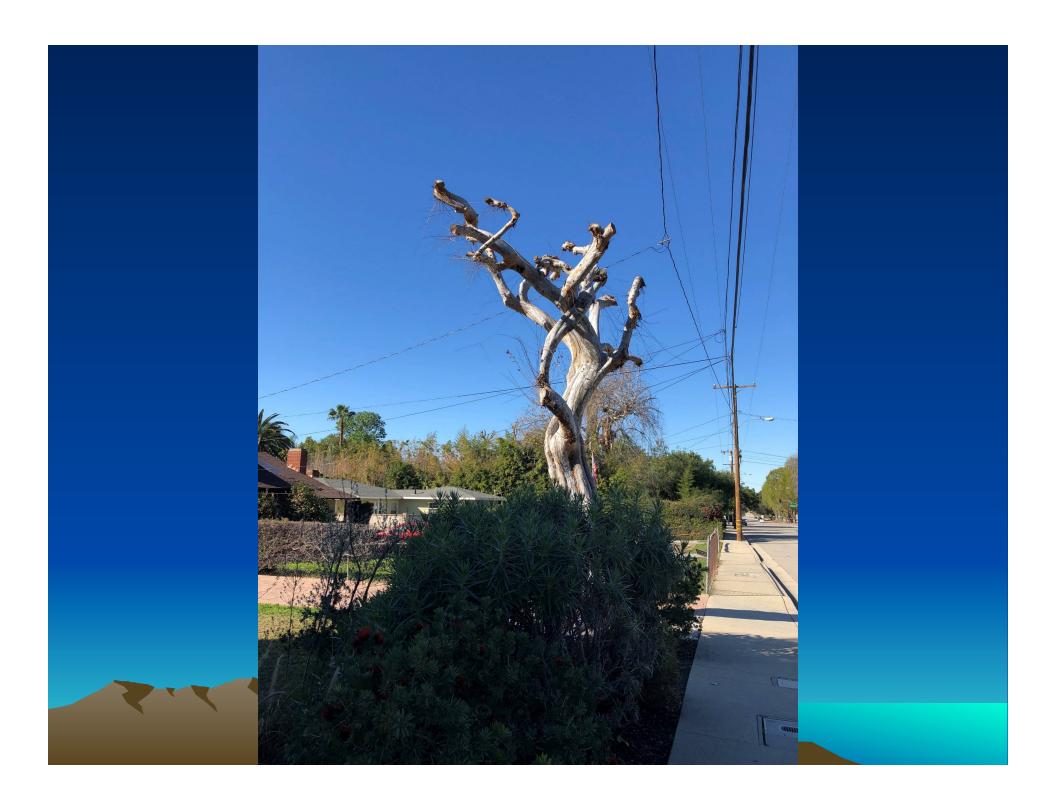
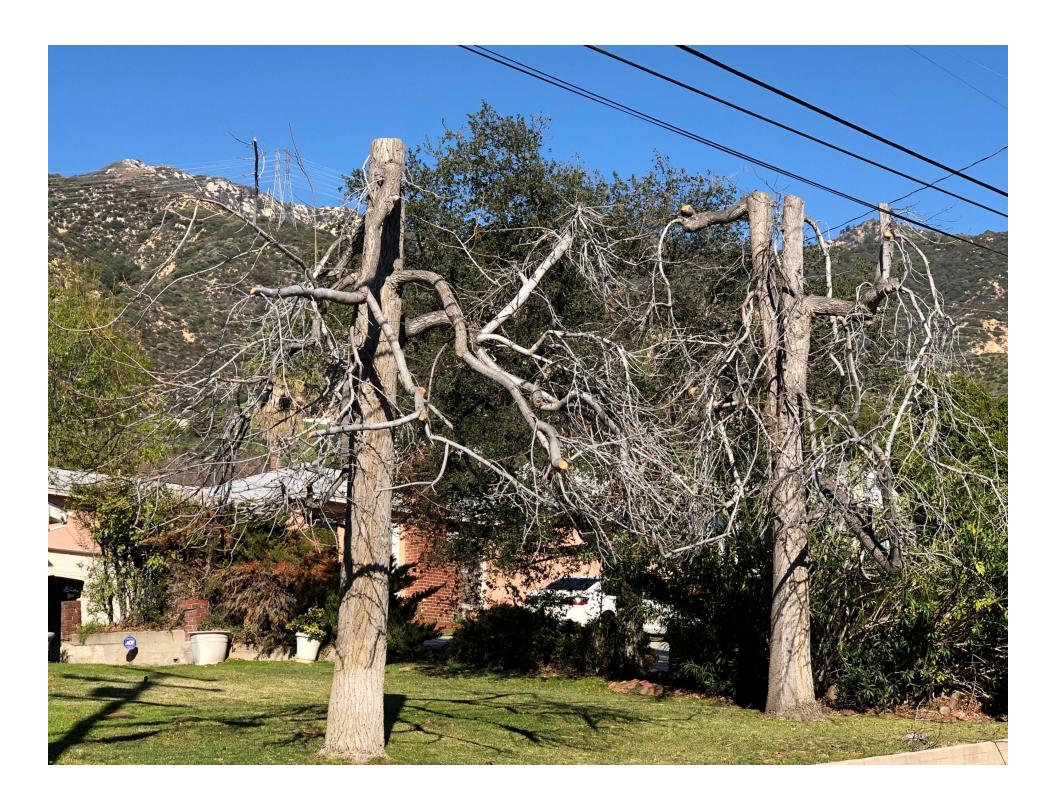
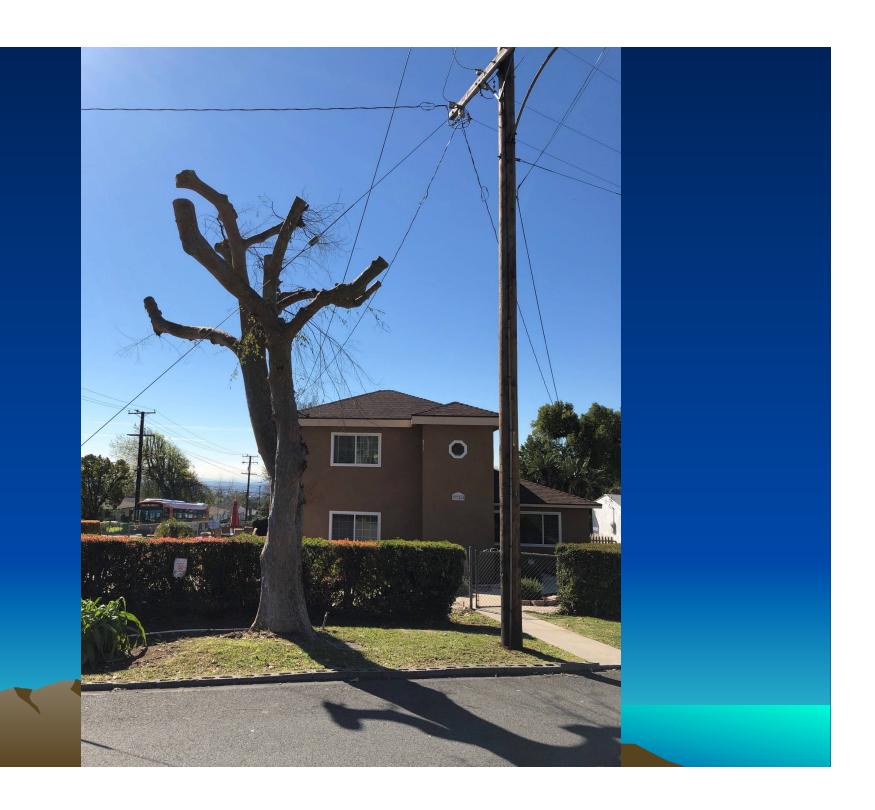
Topping

- Not considered an acceptable arboricultural practice
- Takes stored starch (energy) from the tree to restore foliage. Can weaken tree.
- Promotes poorly attached sprouts that may later fail.
- Promotes decay in the topping cuts
